# Rothner Residence

# **Conservation**

# **Management Plan**

Jefferson University College of Architecture and the Built Environment  
MHP-603: Restoration and Rehabilitation of Modern Structures  
Spring 2020

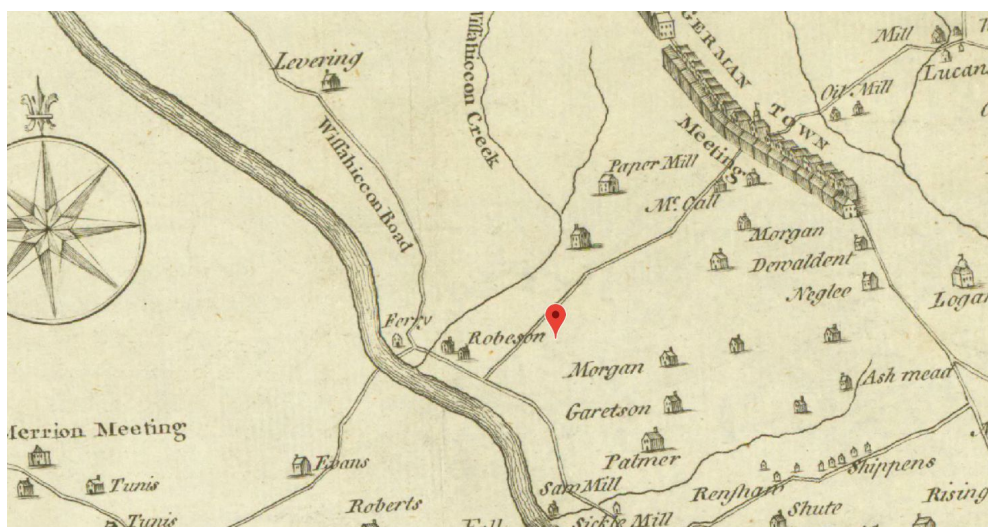
The earliest map of the area that was found dates to 1760. What can be seen from this map is that the property is unlisted, therefore it can be speculated it is forest or farm property. It is close to an early Schoolhouse Lane that leads to Germantown in the right hand corner of the map. The closest property that may have had land ownership of the property was either the Robeson family or the Morgan family.

1760 Map by N. Scull and G. Heap above. "PhilaGeoHistory Maps Viewer." Accessed February 18, 2020. <https://www.philageohistory.org/tiles/viewer/>.

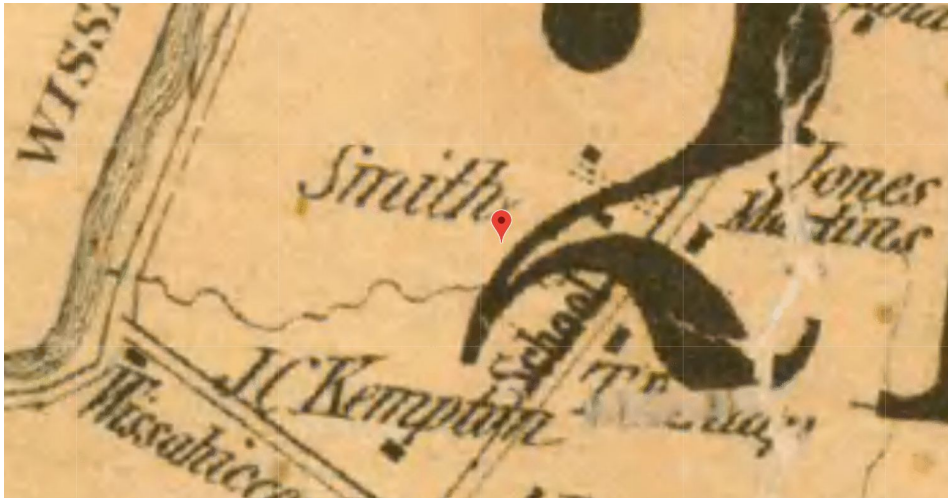
In an 1855 map as seen below it can be noted that Schoolhouse Lane has been established in its present location. The property, while not entirely clear, seems to be owned by the Smith family who established their house across the street from the property. A stream can also be seen leading into the Wissahickon from the property's location.

1855 Map by R.L. Barnes above. "PhilaGeoHistory Maps Viewer." Accessed February 18, 2020. <https://www.philageohistory.org/tiles/viewer/>.

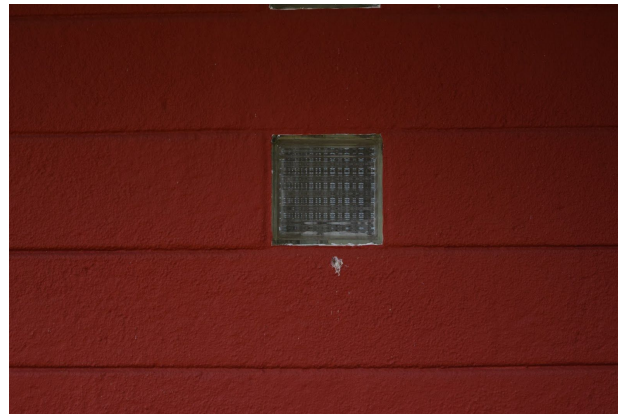
replacement blocks are readily obtainable, although the addition of the pattern, if no longer in print, could be custom matched.

*Fig. 3.1: 8x8 Glass Block*

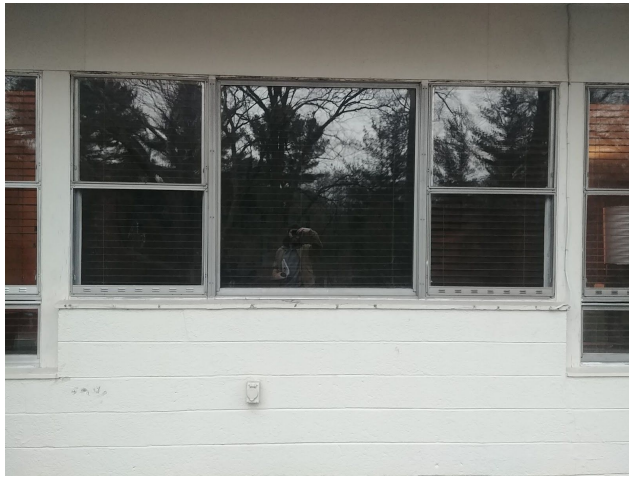
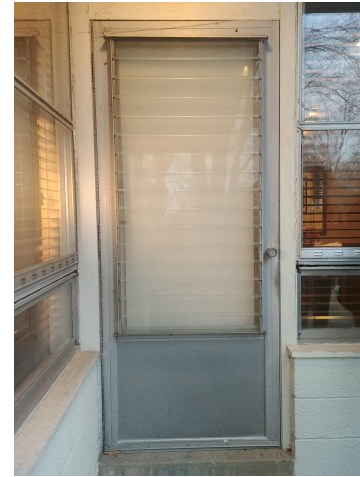
The original windows in the house were manufactured by Cupples Aluminum Windows, and the replacement windows were manufactured by Thermador. Cupples was established in St. Louis, Missouri in 1946 and closed in 1994. The company was renowned for innovative advancements in glass fabrication as well as the fabrication of custom designs. Aluminum windows are well known for lightweight, easily installable windows, and Cupples later became known for the fabrication of glass facades. Some of the custom fabrications included work for I.M. Pei, SOM, and Yamasaki for the World Trade Center. Cupples offered Multiple standard shape and sized windows that were mass produced for ease of production and readily available for purchase. The windows ranged from different styles of windows as well as operable and inoperable windows, see Figure 3.2. Aluminum windows are a rust resistant window option that were available in varying sizes, gauges, finishes, and offered different coatings to be applied to the windows. The windows were believed to be an easy to install, low maintenance option for windows. The construction of windows offered was a screw assembly style, as well as a welded or mitered option. Aluminum windows also offered both screen and storm inserts for insulation or circulation purposes. One Aluminum screen door was also installed off of the dining room door Figure 3.3. While the manufacturer is unknown It is of the same material and construction type of the windows.

Figure 3.2: Image of Aluminum window # 5 and Figure 3.3: Aluminum Door off Dining Room.

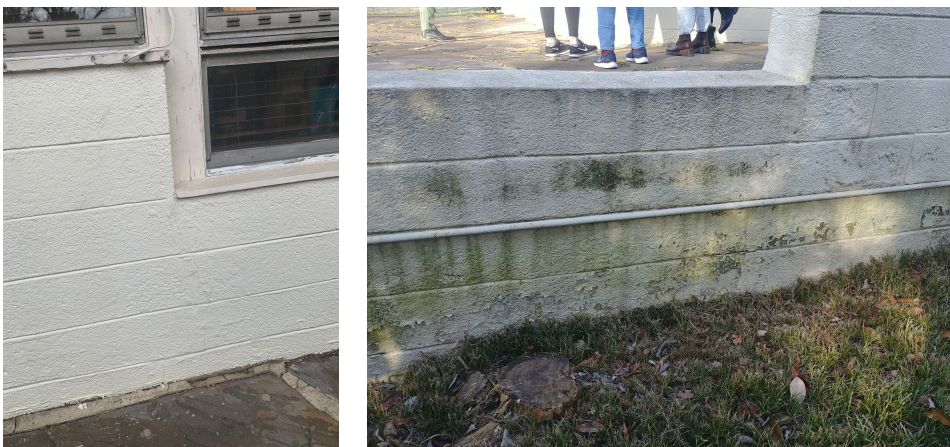
The house and the garage are made of CMU block coated with several coatings. The garage uses 12" x 16" CMU blocks and the house uses 8" x 16" brown CMU blocks. The coatings are as follows: brownish CMU block, a stucco coating with greenish aggregate, a white paint, and an elastomeric white coating. The coatings are generally in good condition, but there are many areas where repairs are evident especially by the openings of windows (see Fig. 4.1). Some are active but a majority of them are repaired and stable. There seems to be no method to allow the wall to expand and contract and so this may be why at the openings, which are the weakest points of the wall, cracks are appearing. There is also peeling coating by the retaining wall in the rear with green staining (see Fig. 4.2). The staining pattern and the flatness of the stain is indicative of algae. With the conduit there, it may act as a surface that catches water and directs it towards the wall. This area is also well shaded by trees and foliage that line the edge of the property and so that creates a suitable environment for the algae to grow.

Fig. 4.1: Repaired crack on west elevation; Fig. 4.2: Algae on south elevation retaining wall.

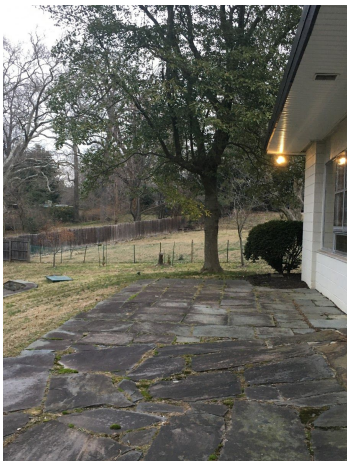
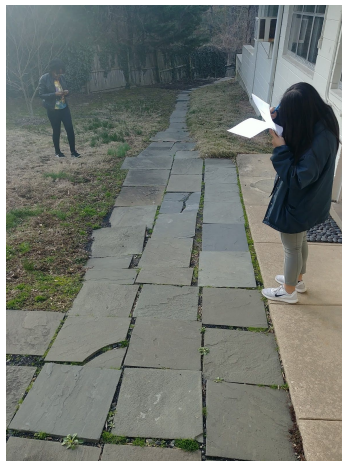
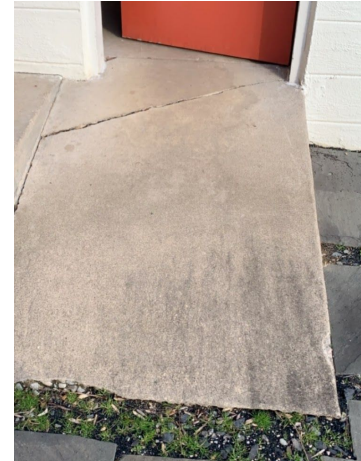
The hardscaping is made of three different periods of masonry and then the asphalt. The front walkway, the area by the garage and laundry room door, and part of the walkway to the pool use concrete. The flagstone, which is made of schist, covers about half of the patio on the west side and the steps to the pool (Fig. 4.3). And the bluestone square pavers cover the other half of the patio and also make up the area around the garage door and create the path down to the pool on the west elevation (Fig. 4.4). The asphalt only exists on the front side of the house. The concrete is generally fair, although the concrete ramp is cracked and the front walkway is weathered from site runoff as evidenced by the exposed aggregate and discoloration (Fig. 4.5). The cracking of the ramp may be due to settlement of the ramp itself, detaching it from the garage. The flagstone is a little displaced and there is some need to it in between and the pavers face the same issues, with some cracking involved.

*(L-R): Fig. 4.3: Flagstone on the west side; Fig. 4.4: Square schist pavers on the south side; Fig. 4.5: Crack on concrete ramp on west elevation of the garage.*

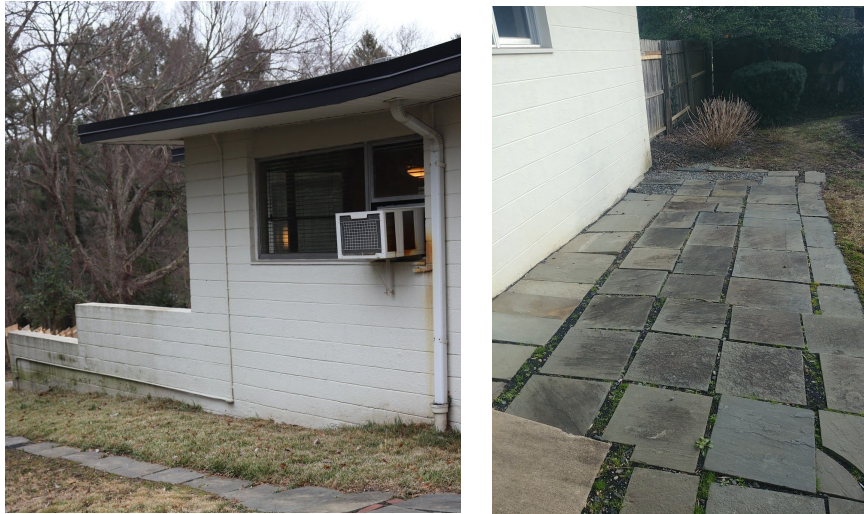
The site drainage consists of three different components: downspouts, a drainage grate, and areas of gravel which we assume is to help with drainage. There is one visible downspout where the roof slopes meet on the west elevation with three other locations for downspout openings on corners of the house, but with no downspout (Fig. 4.6 ). Though to help, there is drainage gravel near these areas where the house is susceptible to water

draining on the site, specifically on the east elevation (Fig. 4.7 ). And there is also the drainage grate in the middle of the driveway, adding additional drainage help.

*(L-R): Fig. 4.6: The only downspout located on the south elevation; Fig. 4.7: South corner of garage without downspout.*

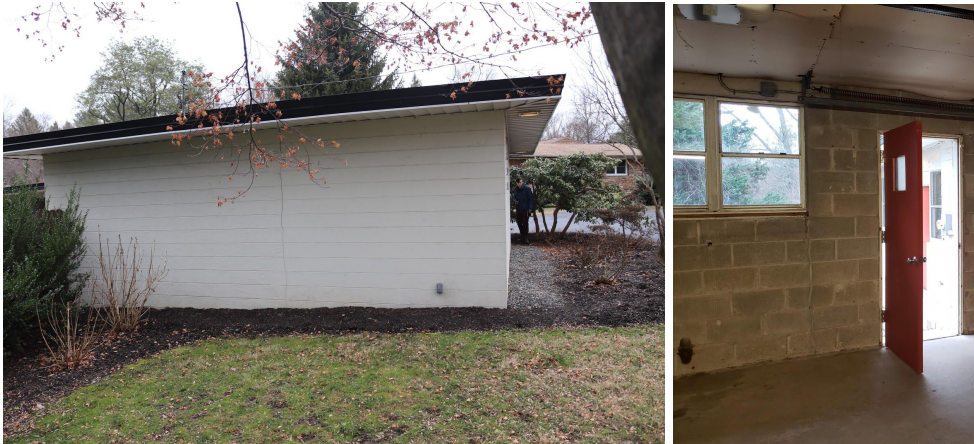
The garage has the same construction and almost the same coatings as the house. It has a parking coat that is different in its color and appearance. Clearly the addition uses similar materials, but because it was added later, the materials are not exactly the same which may cause problems relating to thermal movement due to differing material expansion and contraction. The largest of the active cracks is located on the west elevation of the garage (Fig. 4.8 ). The location aligns with the extension of the garage which may be related to difference in material movement like mentioned earlier or the attachment to cold joints between the old and new materials. There is also an active crack which is underneath the only window of the garage (Fig. 4.9 ). It is visible both inside and outside indicating ongoing movement. This may be caused by the lack of a downspout on the nearby corner causing water to constantly hit that area, making it more compressed than the surrounding soil.

(L-R): Fig. 4.8: Active crack on the east elevation of the garage; Fig. 4.9: View of crack below window of garage.

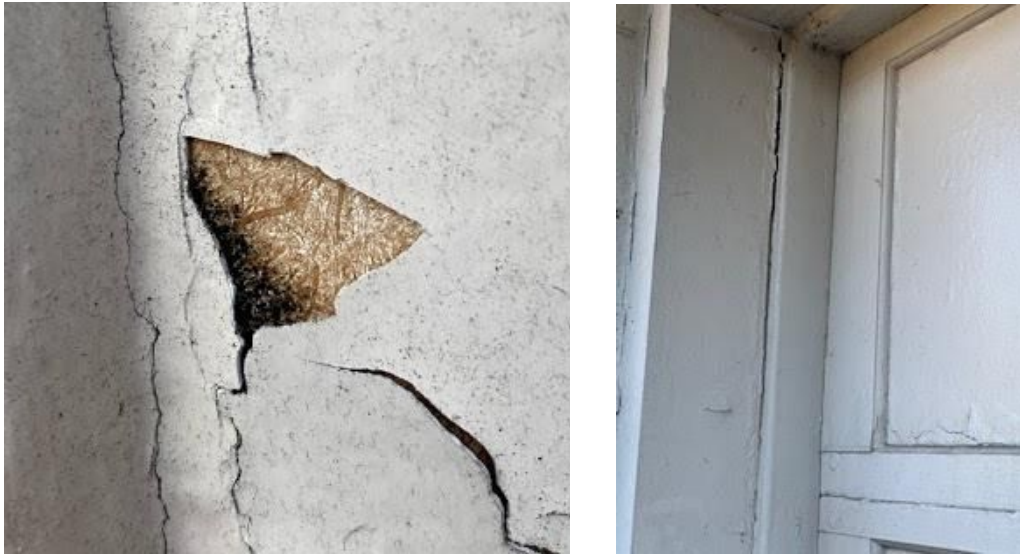
The garage door is made of an oriented strand board (OSB) base with dimensional lumber used as paneling trim. The OSB is covered with white paint that is cracking and peeling across the entire surface. In many places, the OSB is clearly visible behind the paint where pieces of peeling paint have completely come off. Behind some of the paint surrounding these exposed areas, there appears to be mold growth between the paint and the OSB substrate (Fig. 4.10). This alerts that moisture is entering this gap behind the paint and is left to sit, which could potentially lead to moisture damage of the OSB if left untreated. It is unclear whether the peeling paint on the garage door is from an incompatibility between an older oil-based paint and a newer latex-based paint or from it still being the original oil-based paint that has lost its elasticity over time as the OSB substrate expands and contracts in heat.

(L-R) Fig. 4.10: Exposure of OSB behind peeling paint. Fig. 4.11: Garage door trim peeling from wall.

The trim surrounding the garage door is made of dimensional lumber, possibly 1"x4" and is seen to be peeling away from the wall of the garage (Fig. 4.11). This could possibly be due to moisture traveling down from the trim above, potentially from a small leak in the roof assembly. However, further investigation would have to be made to clarify that cause.

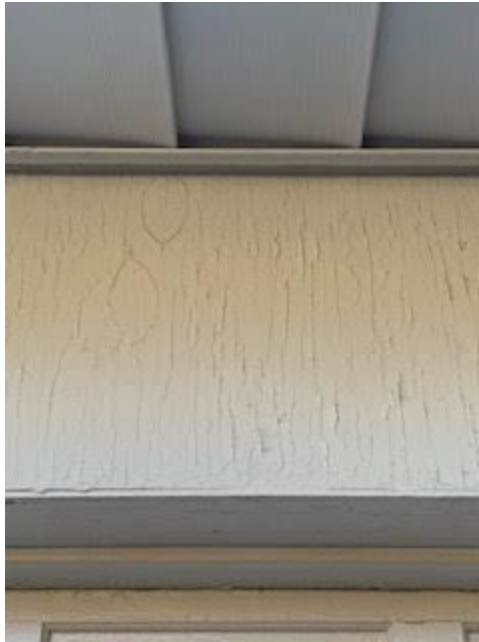
The header above the garage door is made from plywood, which is seen in the presence of the plugs in what were knots in the wood during manufacturing (Fig. 4.12).<sup>43</sup> The white paint coating the header is cracking in the direction of the wood grain, which is either caused by paint incompatibility if there are new and old layers of paint, or elasticity loss if the paint is the original oil-based paint. Plywood is susceptible to warping due to changes in moisture within the wood as well as expansion and contraction, which could also be a large factor in the cracking of the paint.

*Fig. 4.12: Peeling paint on garage door header.*

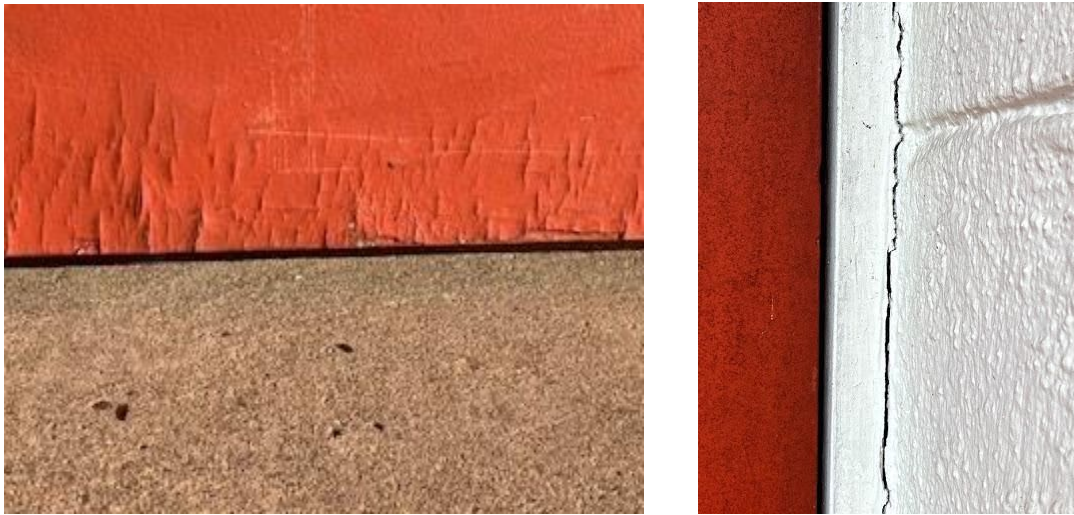
The jamb of the red door is made from dimensional lumber and is painted white. The door currently closes with the help of a closer, but is slightly off-kilter within the frame, causing a jarring action when left to freely close. This is causing the jamb on the hinged side of the door to pull from the CMU wall of the adjacent garage and for the door to sit askew and not close completely (Fig. 4.14).

(L-R) Fig. 4.13: Peeling paint at bottom of red door. Fig. 4.14: Jamb of red door pulling from CMU wall..

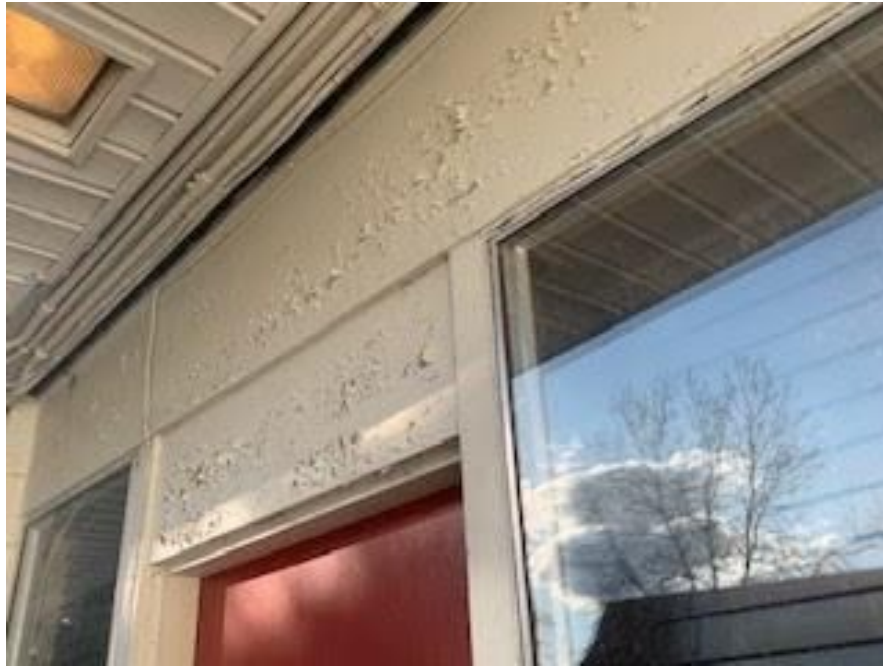
*Fig. 4.15: Most severe peeling paint on the window and door panels of the west elevation.*

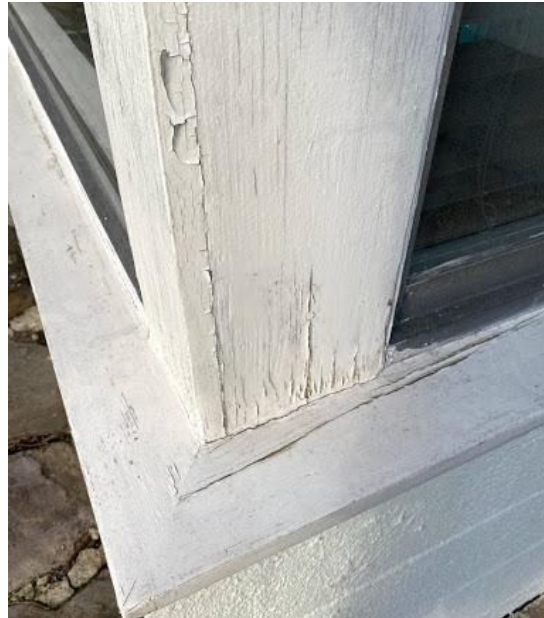
The columns at the corners of the windows of the living room on the north elevation are made from dimensional lumber, possibly 3" x 3" posts, and are coated with a white paint. There is cracking seen in the paint running in the same direction as the grain of the wood underneath (Fig. 4.16). The cracking of the paint here can be caused by similar situations as explained above in the window and door panel description: incompatible paint layers or aging original oil-based paint.

*Fig. 4.16: Corner column on north elevation with cracking paint.*

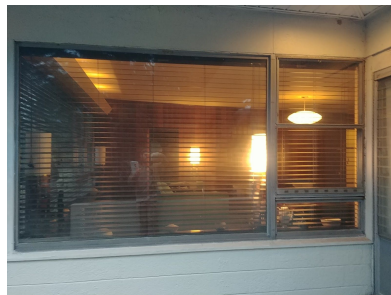
Almost all of the windows are prefabricated A200 series aluminum windows manufactured by Cupples Aluminum Corporation. There are a combination of double-hung and fixed windows at varying scales (see Figure 4.17). Glass storm windows are mechanically attached to the window frame with screws, making them inoperable. Pull tabs on the storm windows suggest they were originally removable and could be replaced with a screen.

*Fig. 4.17 Both operable and inoperable windows.*

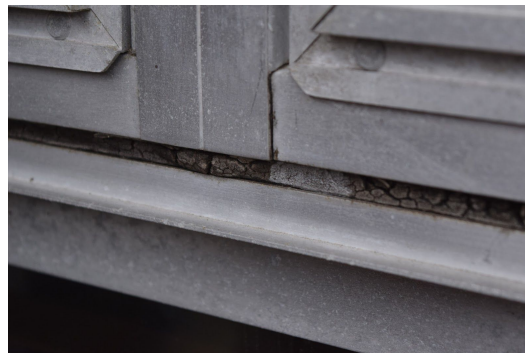
Overall the windows on the house are in fair condition. There are areas of deterioration present in the sealants for most of the original windows, but collectively they are performing adequately. A black glazing compound is present between the fixed and double-hung windows, which has dried up and is beginning to crack and flake away (see Figure 4.18). A few windows on the house have had recent repairs with sealant replacement and pane replacement. General cleaning to all windows is being done by the current owner with the use of aluminum jelly or phosphoric acid jelly. The owner is using this product to remove oxidation which has formed on the aluminum frames. Several of the panes of glass have sustained cracks. Further investigations should be performed to ensure the integrity of the window is not compromised.

*Fig. 4.18 Showing cracked gasket between frames.*

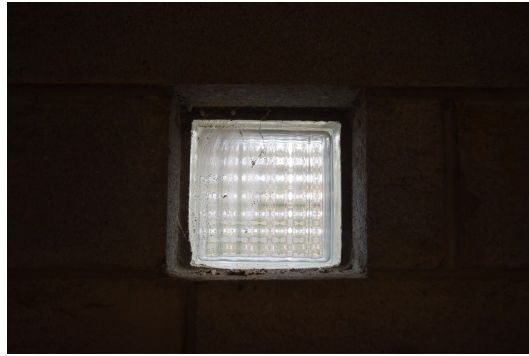
The main windows on the garage match those on the house, but are newer. These are the only aluminum frame windows on the building which are not covered by a storm window. These windows are overall dirtier than those on the house, and there is an abandoned mud wasp nest located in the exterior track of one of the windows. There are also 8"x8" Argus Perpendicular Pattern Corning Glass blocks on the street-facing elevation of the garage, which are in excellent condition, besides some cosmetic smearing of mortar from the adjacent masonry (see Figure 4.19).

*Fig. 4.19 Showing Glass Block in garage.*

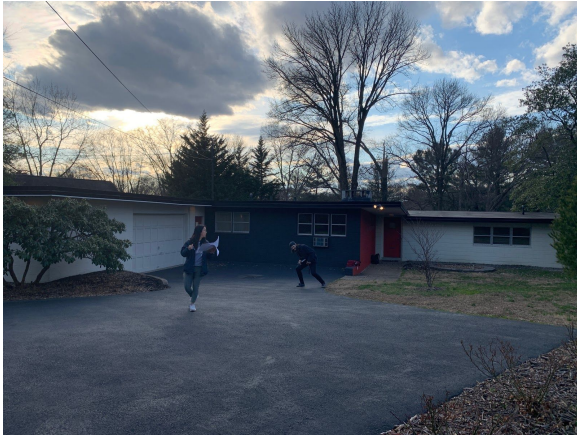
The Rothner Residence completed in 1949, designed by Norman Rice for the Jacoby family. The home sits on West School House Lane, in Philadelphia. In this home rice seems to have taken the same approach that was taken at the Berenstain residence. The home has been angled from the street and has a significant setback from the home's property boundaries. The home is somewhat obscured from view from the street. Likewise, the home has significantly more window openings in its rear elevation than in its front façade. On the rear elevation the windows look out onto the properties backyard that is private to the inhabitants of the home and his/her guest.

Figure 14. Front of the Rothner residence completed in 1949 by Norman Rice.

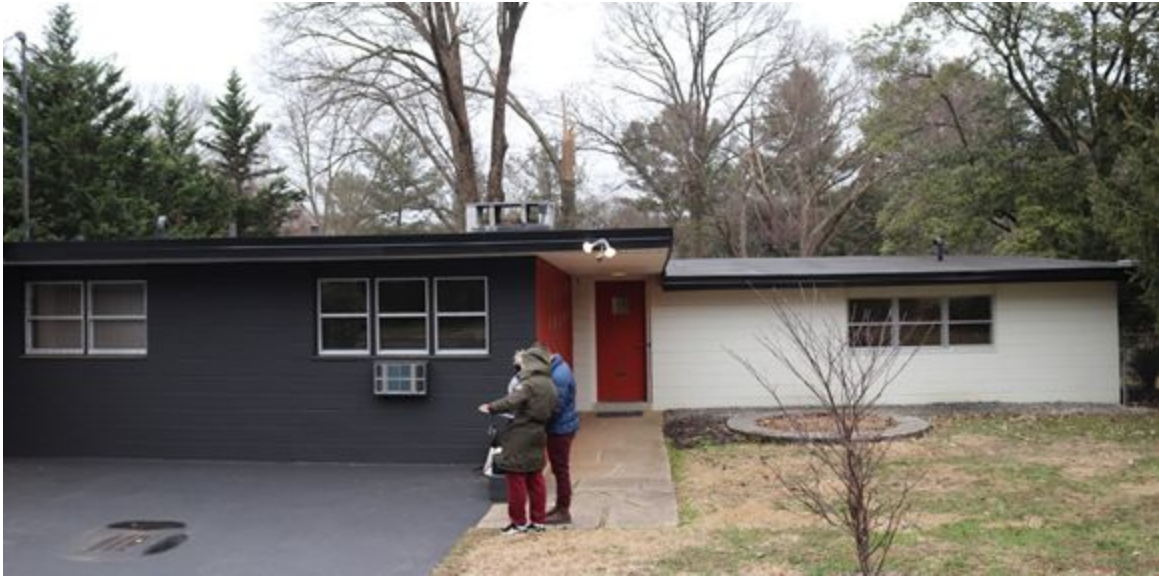
*Figure 13: Rothner Residence*

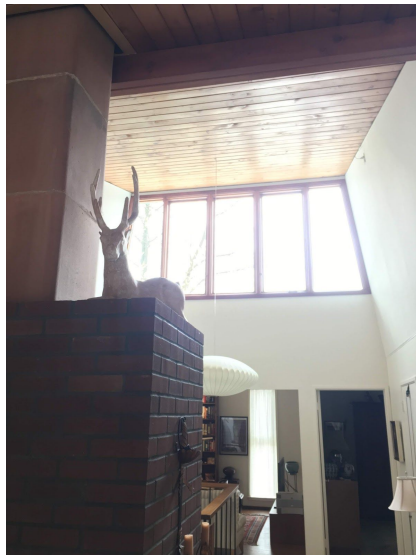
### 3909 Vaux Street Philadelphia, Pennsylvania

3909 Vaux Street is a short walk from the Rothner Residence, in the same neighborhood of East Falls. 3909 Vaux Street is a two-story brick building. The home features key concepts such as a private façade with smaller openings on the west elevation against Vaux Street. The east elevation facing the backyard has larger openings connecting the interior and exterior. The program of this interior divides entertaining, private, and utility spaces revolving around a central hearth. Utility spaces are located on the south side of the building, while private spaces like bedrooms are on the north side. Entertainment spaces such as the living room on the east side of

the residence. A garage, guest bedroom, and studio occupy the ground floor while primary areas like the kitchen, dining room, living room, and master bedroom occupy the second floor. There is an explicit use of compression and expansion throughout the house. The living room, dining room, and master bedroom have high ceilings with lots of light while the kitchen and ground floor.

Some key features to highlight in the home are the warm paneled ceilings in the living room. A focal point of a large dormer skylight brings high natural light into the space highlighting the staircase and central hearth. Glass block construct vertical light strips throughout the house on the west elevation and throughout the house.

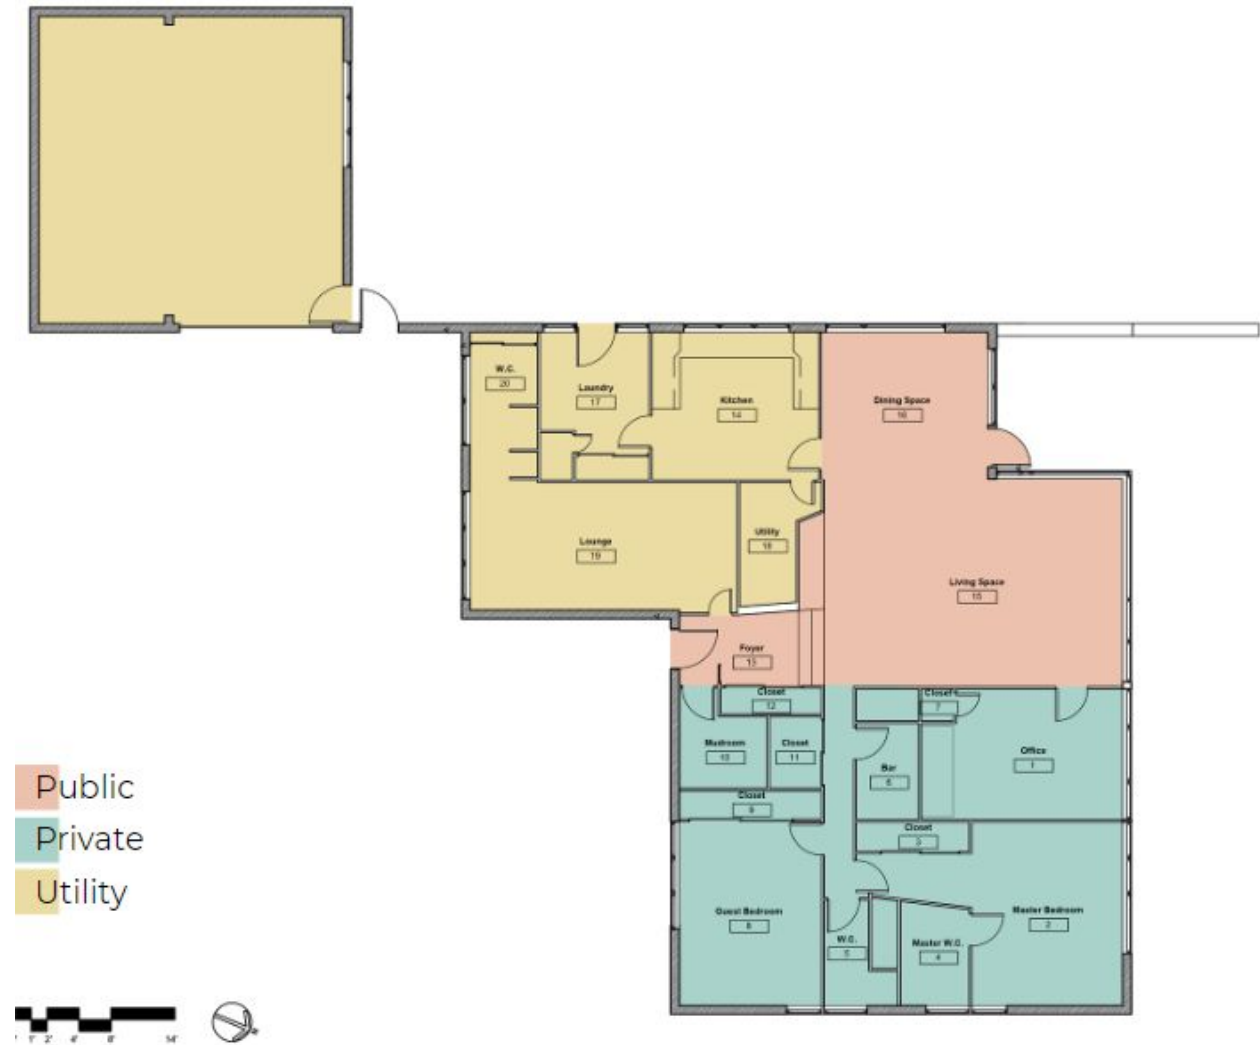
- The division between entertaining, private, and utility spaces
- The focal point of a central hearth
- The horizontality expressed through the masonry coursing, windows, and extended eaves
- Private façade hid from street view with smaller window openings

The Rothener Residence, like all other of the analyzed projects, feature a division of entertaining, utility, and private spaces. The center corner for entertaining, the south wing for utility areas, and north wing for private spaces. There is a central hearth in which the spaces rotate. The façade of the house is hidden from the street and features smaller openings. (For a more detailed description of the interior see Section 3.4.)

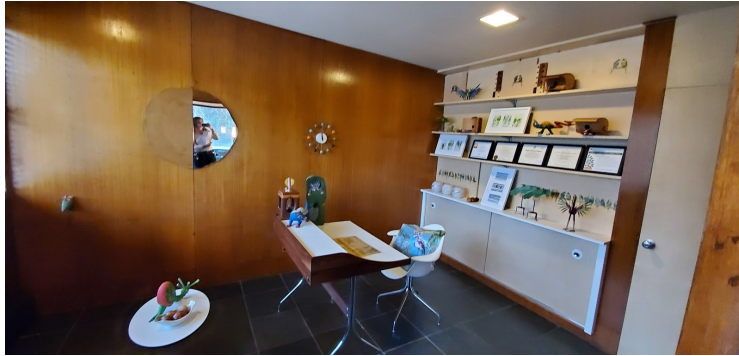
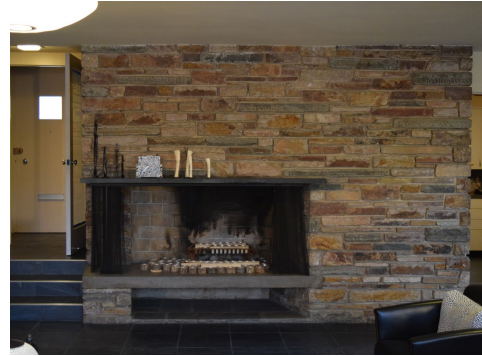
## Key Features

- Warm paneling in the living room and office
- Manufactured aluminum windows
- Built-In shelves in the living room and office
- Central random ashlar fireplace

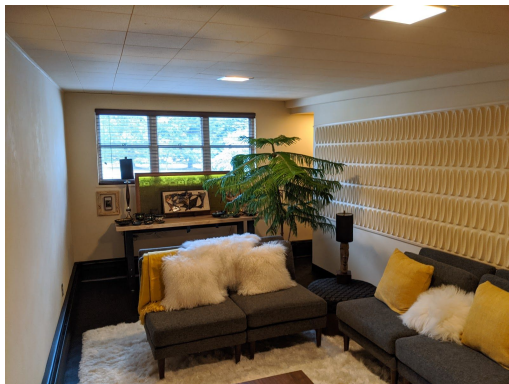
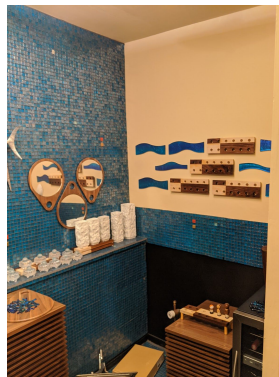
## Prior Renovations

- Adaptation of the old garage into a den
- Adaptation of the darkroom into a bar
- Replacement of the asbestos floor with slate
- General maintenance and repairs

The figure above identifies the level of impact the previous renovations made of the identity of the home. Major modifications indicate additions and major programmatic changes like the adaptation of the original garage, a utility space, into a den, entertaining space. Moderate modifications indicate a minor change like the darkroom to a bar, maintaining the concept of private spaces. Minor modifications include general maintenance.

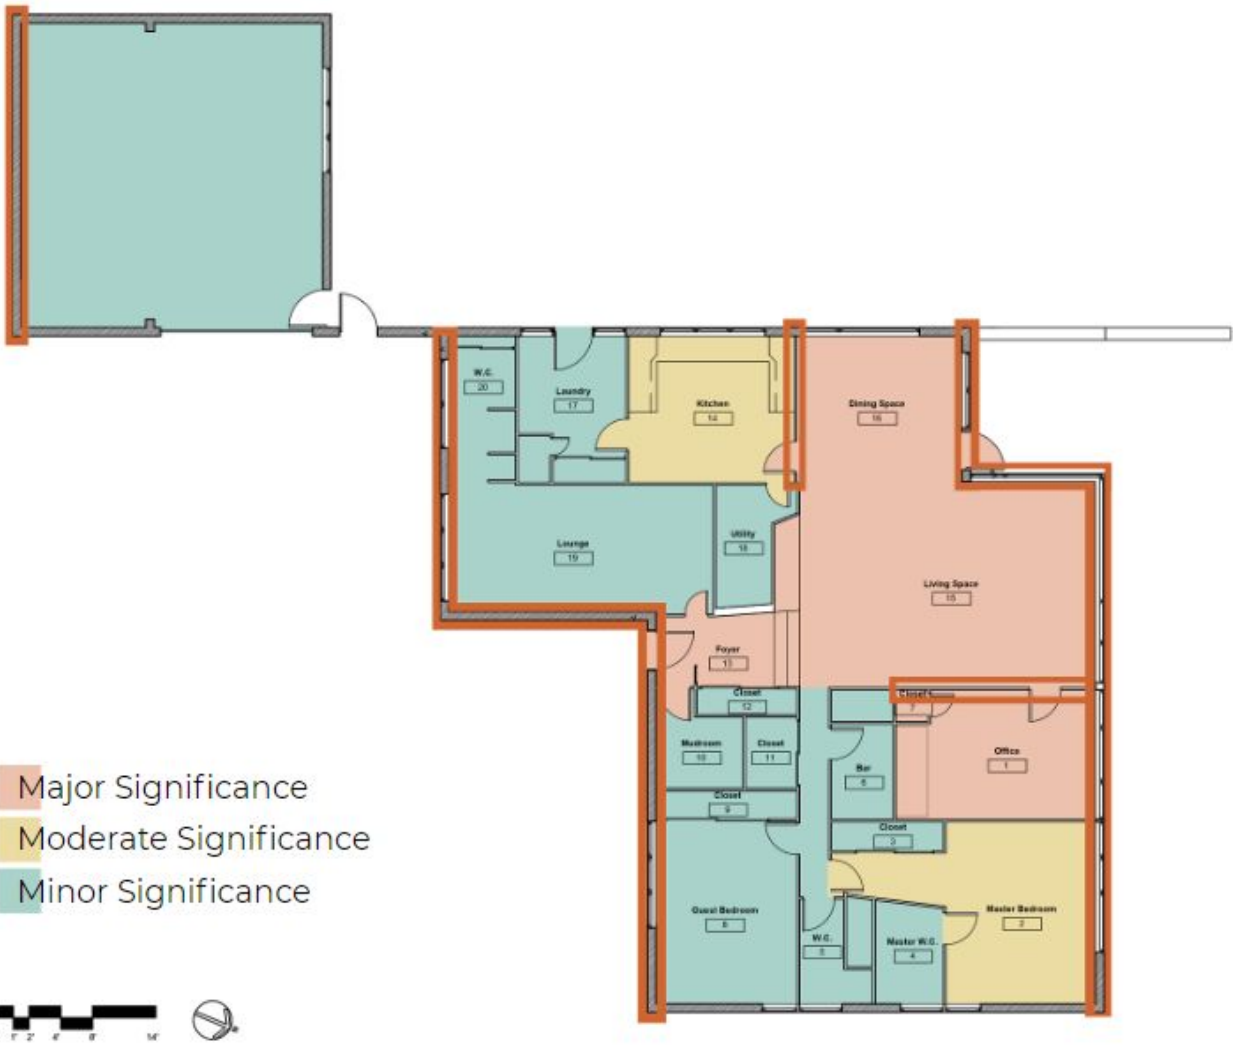
### Hierarchy of Spaces

The hierarchy of the spaces in the Rothner Residence reflects the organization and the presence of key features or concepts. The living room, dining room, office, and entrance are the most significant featuring the most defining features including the wood paneling and fireplace. The master bedroom and kitchen rate at a moderate significance due to their organization. The master bedroom is located along the northwest elevation which is the most significant elevation due to the presence of the windows. The kitchen wall is a clear divider between the entertaining and utility spaces, the removal of the kitchen wall would destroy that visual divide.

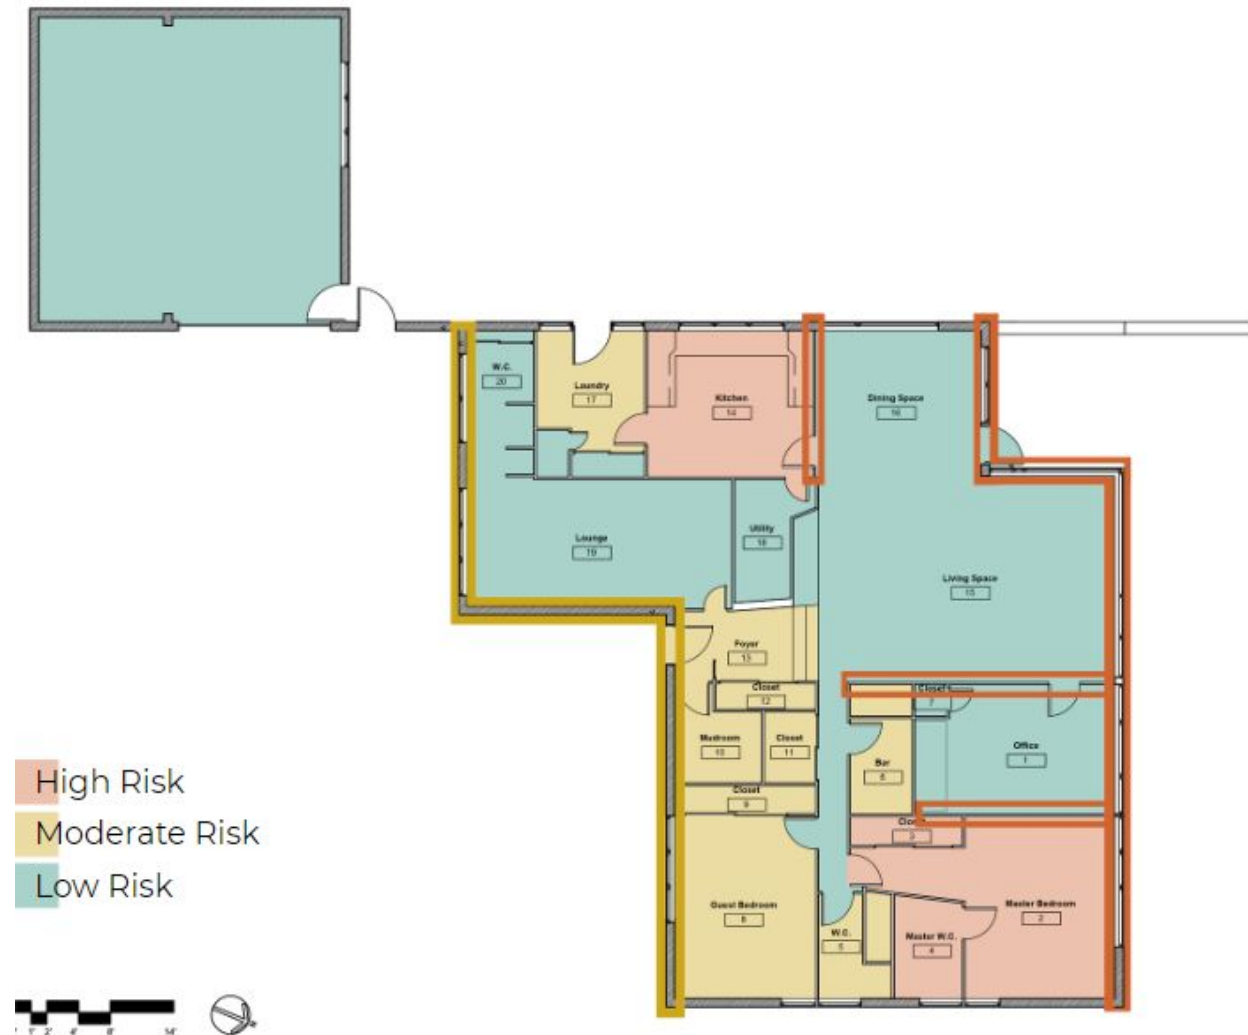
## Risk Levels for Modification

The levels of risk identify potential features and areas new owners would most likely modify. Based on contemporary standards, an owner would want a large master bedroom and kitchen. The cypress paneling is “outdated” to most contemporary design and would be at risk of removal or painting. As a result, the spaces adjacent to the kitchen and master bedroom are put at moderate risk if the owners chose to demolish walls to open up space. The low-risk spaces include the previously renovated and most desirable portions of the house like the renovated den, detached garage, living room, office, and dining room.

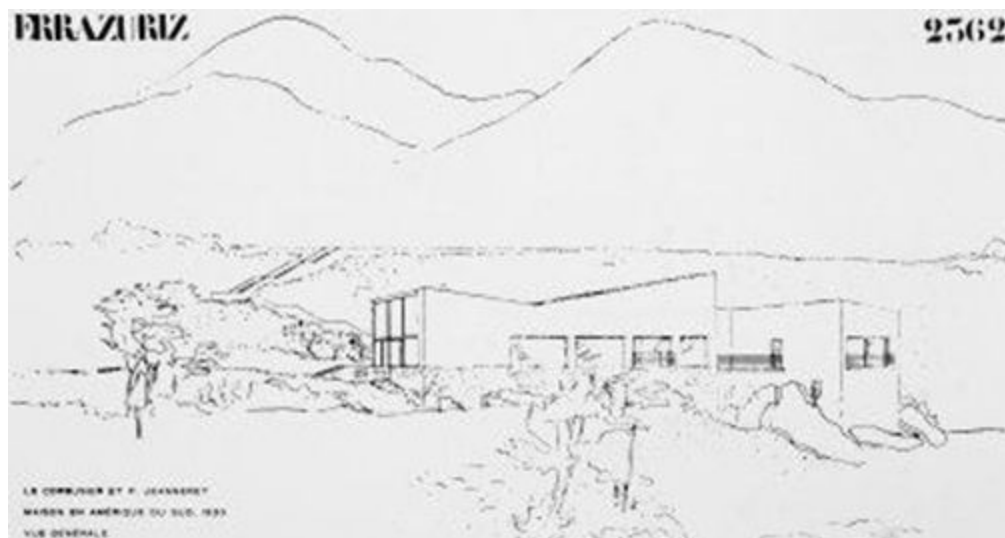
Figure 1: *Maison Errazuriz* A rendering done by Le Corbusier for Eugina Errazuriz's proposed house design showcasing the first use of the butterfly roof. Unfortunately, it was never built.

Though credit is often given to William Krisel for the creation of the butterfly roof, the concept was in fact conceived by Le Corbusier in 1930 for a project in Chile that was never built (Figure 1), though no information was found stating why Le Corbusier decided to create or use the new roof form. The design for the home of Eugina Errazuriz in Zapallar, Chile was to overlook the Pacific Ocean from a remote site and to respond to the uneven terrain through the use of natural materials and Le Corbusier's new butterfly roof design, which was a "distinctive departure from the flat roofs that had become characteristic of the 1920s."<sup>1</sup> Unfortunately, the plans fell through as Eugina went bankrupt before the project could break ground.

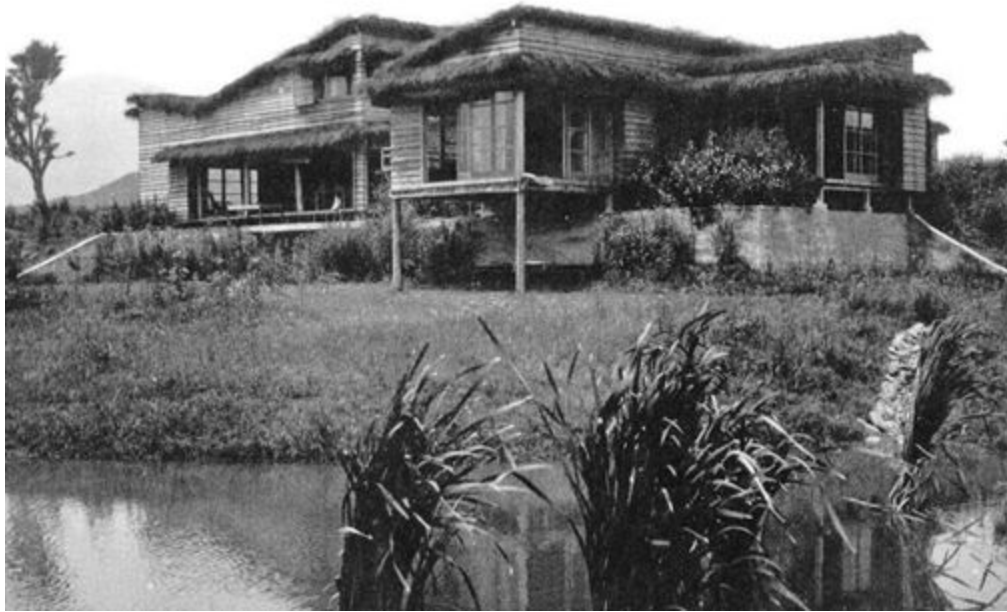
Figure 2: *Summer Home* A photograph of Antonin Raymond's summer home in Karuizawa, Japan built in 1933. It was almost a direct copy of Le Corbusier's *Maison Errazuriz* and was later published in an architecture magazine in 1934.

In 1933, Czech architect Antonin Raymond adopted the butterfly roof design for his summer home in Karuizawa, Japan (Figure 2) with a design that was almost identical to Le Corbusier's *Maison Errazuriz*. The design would later appear in *Architectural Record* in 1934, much to the surprise of Le Corbusier, though he only had praise for Raymond's application of his former design.<sup>2</sup> The new roof style was again used in 1945 for a more experimental project by the United States government in its search for pre-fabricated house designs for post-war America. Marcel Breuer designed the Geller House I on Long Island, New York (Figure 3) as an option for one of

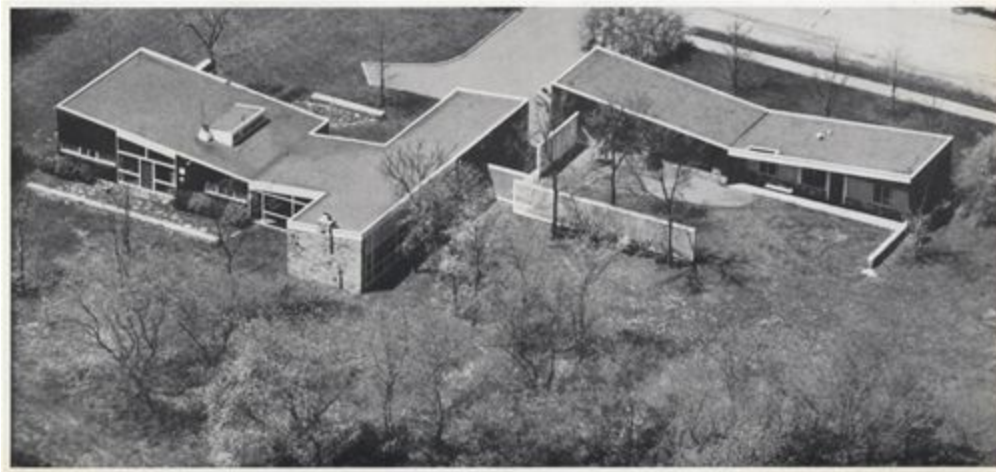
Figure 3: *Geller House I* An aerial view of Marcel Breuer's Geller House I with the butterfly roof clearly visible in the design.

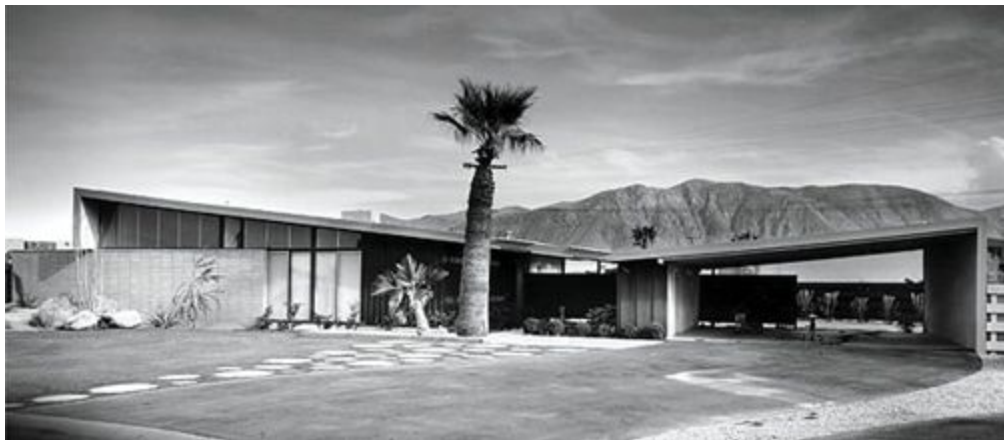
Figure 4: *Butterfly House* A photograph of one of over 2,500 homes constructed in Palm Springs with a butterfly roof after 1957. Krisel and Palmer brought the butterfly roof to the masses.

It was not until 1957 when the butterfly roof became widespread in its use in residential applications. In Palm Springs, California over 2,500 homes boasting butterfly roofs were designed by William Krisel and partner Dan Palmer (Figure 4), and built by Alexander Construction Company.<sup>4</sup> Krisel's designs and implementation of them at such a large scale helped shape the location's desert community and inspire other architects and designers to experiment with the new roof design as well. Krisel's commissions eventually reached over 30,000 homes and reached from San Francisco to San Fernando Valley.<sup>5</sup>

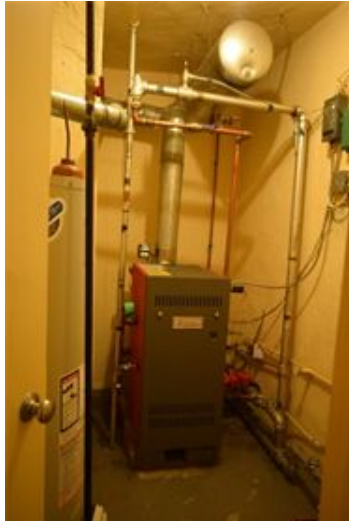
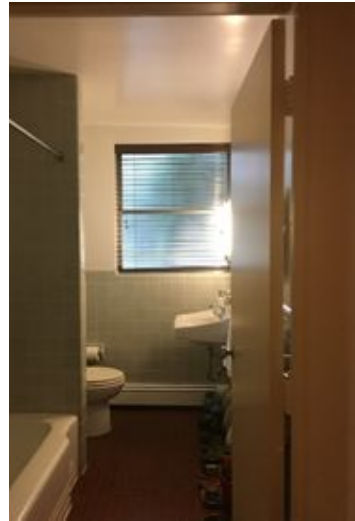
*(L-R), Fig. 1: The gas boiler, installed in 2019. Fig. 2: Added baseboard radiators in the bathroom.*

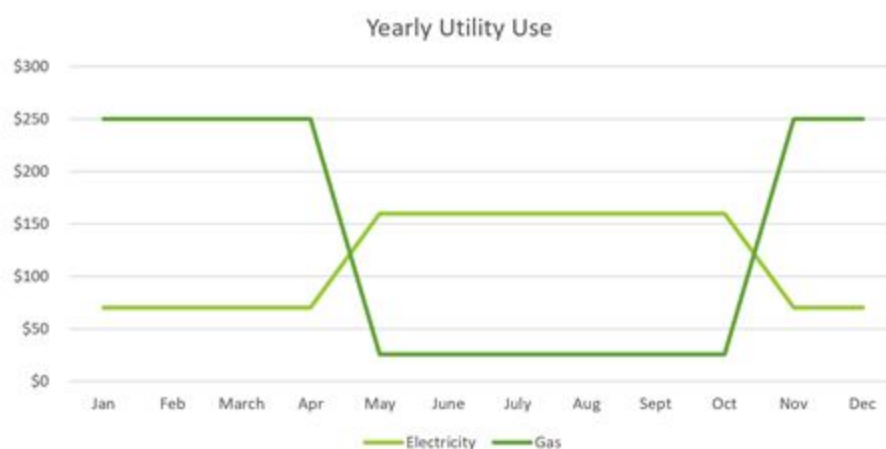
*Fig. 4: Janet Grace's yearly energy use of electricity and gas plotted by her bill amounts.<sup>11</sup>*
